SERIES-900 FIXED WINDOW (NON-IMPACT)
 NUAIR WINDOWS AND DOORS
 8105 ANDERSON ROAD
 TAMPA, FL 33684
 TEL. (800) 282-6627 FAX (813) 886-9737

drawing no. PW900
 SHEET 2

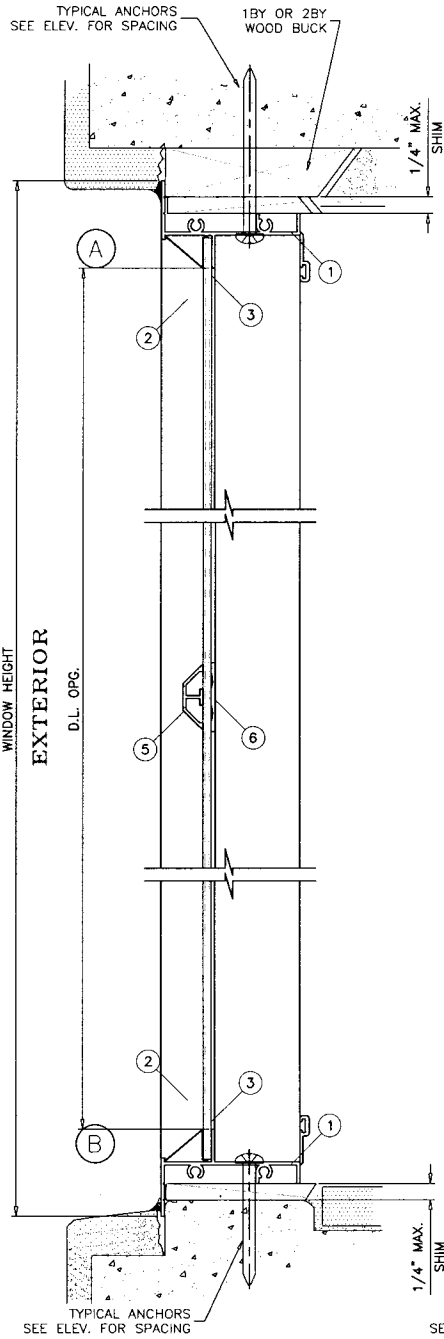
METAL FL # 0027689
 (STEEL OR ALUM. 1/8" MIN. THICK)
 STEEL : $F_y = 36$ KSI MIN.
 ALUMINUM : 6063-T5 MIN.
