SERIES-9000 ALUM. FIXED WINDOW (IMPACT)
 NUAIR WINDOWS AND DOORS
 8105 ANDERSON ROAD
 TAMPA, FL. 33684
 TEL. (800) 282-6627 FAX (813) 886-9737

drawing no.
 PW9000
 SHEET 2

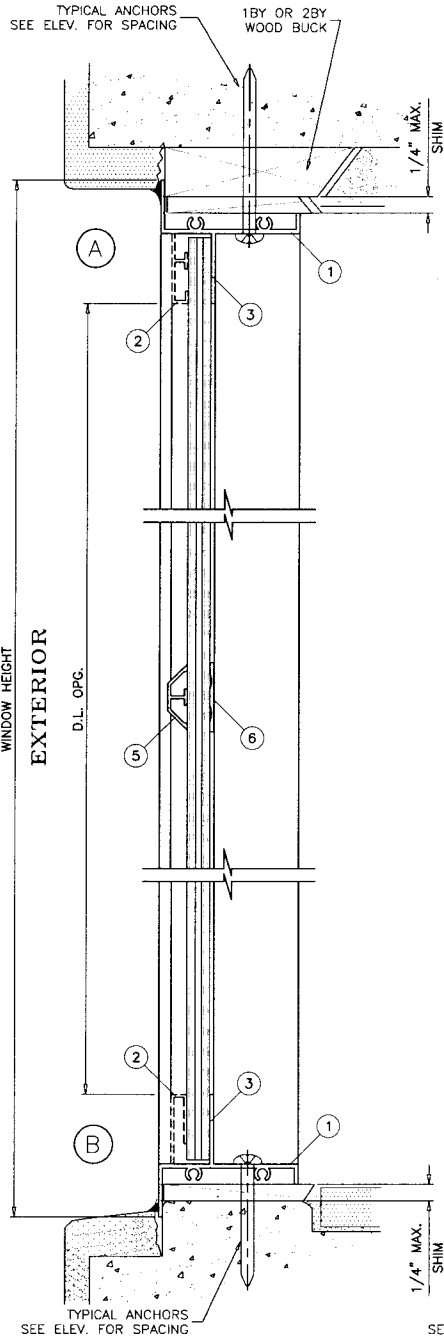
FLANGE FRAME WINDOW

METAL FL # 0027689
 (STEEL OR ALUM. 1/8" MIN. THICK)
 STEEL : $F_y = 36$ KSI MIN.
 ALUMINUM : 6063-T5 MIN.

FAILURE TO SUPPORT THE FRAME USING SHIMS AT EACH FASTENER MAY RESULT IN GLASS BREAKAGE. INSTALLER MUST USE A HIGH-QUALITY, ADHESIVE CAULK UNDER THE FIN OR FLANGE.

ANCHORS TO BE SPACED AS FOLLOWS:
 -ALL ANCHORS NO MORE THAN 4" FROM EACH CORNER.
 -1/4" MASONRY ANCHORS TO BE NO LESS THAN 23" CENTER TO CENTER, OR AT PRE-PUNCHED LOCATIONS.
 -SM SCREWS INSTALLED THROUGH FIN FRAMES TO BE NO LESS THAN 22" CENTER TO CENTER.
 -DECKING SCREWS INSTALLED THROUGH FIN FRAMES TO BE NO LESS THAN 10" CENTER TO CENTER.

TYPICAL ANCHORS SEE ELEV. FOR SPACING
 TYPICAL ANCHORS SEE ELEV. FOR SPACING
 2 BY WOOD BUCK OR STRUCTURE

TYPICAL ANCHORS:

1/4" MASONRY ANCHORS
 INTO 2BY WOOD BUCKS OR WOOD STRUCTURE
 1-3/8" MIN. PENETRATION INTO WOOD
 THRU 1BY WOOD BUCKS INTO MASONRY OR DIRECTLY INTO MASONRY
 1-1/4" MIN. EMBED INTO MASONRY
 DIRECTLY INTO CONCRETE
 1-1/4" MIN. EMBED INTO MASONRY
3/16" DRILLIFLEX SELF DRILLING SCREWS
 INTO METAL FL # 0027689 (1/8" MIN. THICKNESS)

#10 SMS
 INTO APPROVED MULLIONS (NO SHIM SPACE)

SEALANTS:
 FRAME CORNERS SEALED WITH JOINT SEALANT.

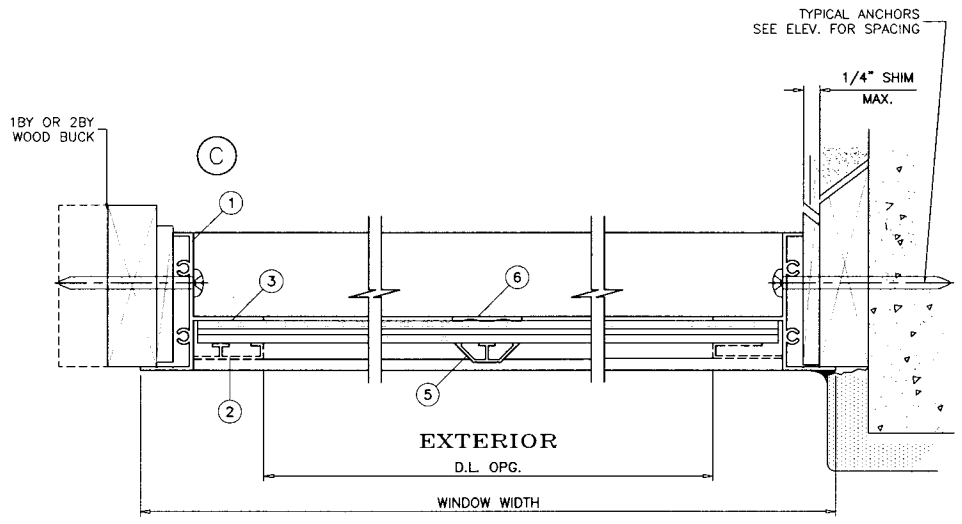
WOOD BUCKS NOT BY NUAIR, MUST SUSTAIN LOADS IMPOSED BY GLAZING SYSTEM AND TRANSFER THEM TO THE BUILDING STRUCTURE.
